## Bush VHF90

Several people have asked about the modification to this set that I mentioned on the [Bush](#) page, so I have decided to include it here. Because I am describing circuit modifications, there are several diagrams, some quite large, on this page.

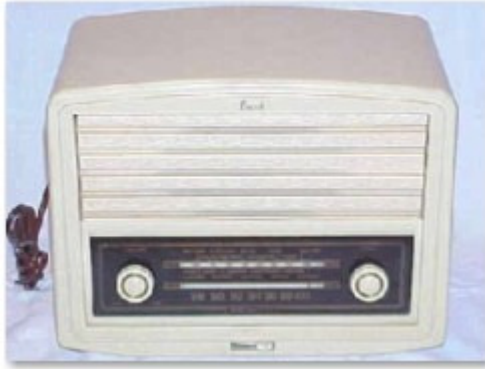
The VHF90 is a small AC/DC set covering MW and VHF bands. When it was released it cost around £17, which was quite expensive compared to similar models from Philips and Pye which also had the LW band and cost around £14. However, the circuit is based on what was then a standard Bush circuit, including the additional IF stage and a decent output stage (using a UL84 when many others were using UCL83 and similar valves). The rectifier is also a valve, in a time when some other manufacturers had moved on to metal rectifiers or similar devices. The advantage of all this, apart from improved performance, is that no large mains dropper is needed. The valve heaters, with the addition of a

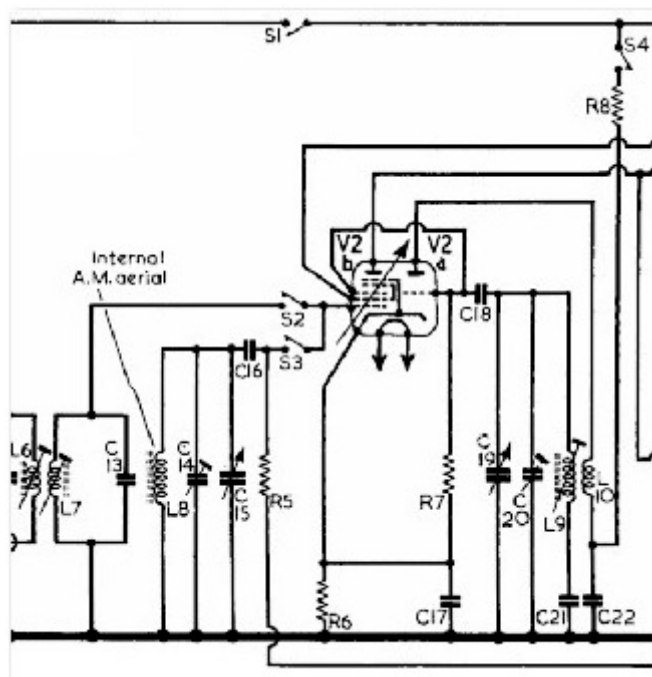
If you are lucky the set will work nicely - but you will almost certainly not be that lucky. The usual problem is crackling on VHF and no reception on MW - caused by the problem with the waveband switch that I mentioned earlier. To prove this, connect a digital meter between pin 2 (control grid) of the UCH81 mixer-oscillator valve and chassis, and switch the set to MW. If there is a positive voltage, the switch is indeed exhibiting the usual problem.

Refer to the first circuit diagram section and switch layout diagram shown here. Both are taken from the Trader Sheet for the set. Switches S1/S4 and S2/S3 are positioned opposite each other, and the wipers are only about 2mm (3/32") apart. S1/S4 switches the HT either to the VHF tuner (S1) or to the anode circuit of the MW local oscillator (S4). S2/S3 switches either the IF from the VHF tuner (S2) or the MW aerial and AGC signal (S3) to the control grid of the UCH81 valve. That is a lot of voltage difference for closely spaced contacts, and after a few years the insulation starts to break down, causing leakage. Since the control grid is at high impedance on MW (due to the AGC circuit), it does not take much leakage to bias the valve fully on and incapable of acting as an amplifier. On VHF the impedance is lower, but the leakage still sufficient to cause a rustling sound.

I have attempted to remove the switch (not an easy job) and clean everything, but this does not solve the problem. Therefore, the only solution is to separate the switch sections, and the only way to do that is to rewire one section of the circuit onto an unused switch section. The problem here is that there are no unused switch sections but it is not too difficult to modify the circuit to obtain one. Refer to the second circuit diagram section here.

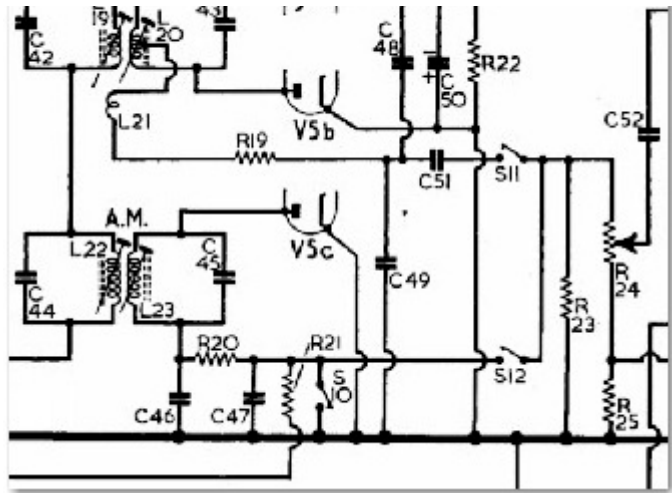
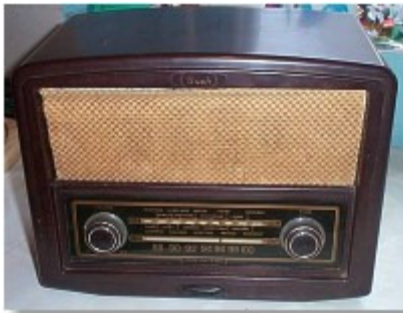
Switch S11/S12 selects the audio output from either the VHF (S11) or MW (S12)

detector circuit for connection to the top of the volume pot. S10 short-circuits the MW AGC line to ground when the set is switched to VHF. S10 is the switch section we are going to make available, since the other half of this switch is already unused. The AGC feed (R21) is then connected to the other side of S12. On MW, the circuit is electrically exactly the same, and on VHF the MW AGC line is somewhat less directly grounded via the volume control and R23. In practice, this works fine.

Physically R23 (180K) is connected between the junction of S11/S12 and one terminal of S10. This terminal is also connected to chassis via a short piece of wire. Cut both these leads from S10. The chassis connection wire can be removed, and the resistor should be able to reach the same chassis tag easily. The other tag of S10 is connected via a single wire, which can simply be removed. R21 (2.2M) can be disconnected from S12 and reconnected to the junction of S11/S12.

The free switch section will be used to replace S1/S4. Since the opposite sections (S8/S9) are also switching HT, this makes sense if we are trying to avoid a repeat performance! Rather than disconnecting the wires from S1/S4, I normally separate it from S2/S3 by bending up and cutting off the fixed contacts, then bending up and cutting off the wiper. Some care is needed to avoid further damage to the switch.

Now all that remains is to connect the tags of the original switch to the tags of the free section. Do not attempt to thread the wires between the switch and the chassis because the capacitive coupling will prevent the circuit from working correctly. I use three lengths of rigid insulated wire, formed about 3mm (1/8") away from the switch. These are a bit prone to being disturbed when the chassis is being worked on but will be fine when the set is reassembled.
